Langley Park Archaeology

The "Roman Bath" folly and pond or swimming pool

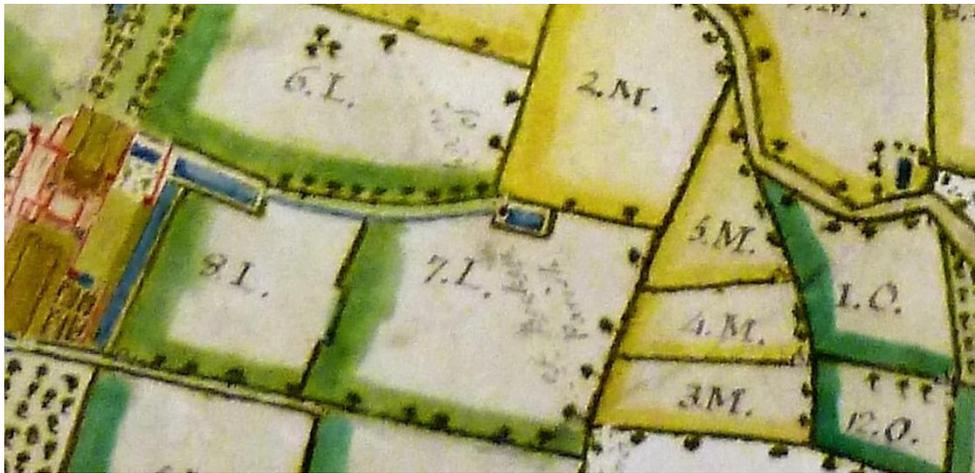
This map in the British Library shows fields, ponds and buildings circa 1735

The 1809 Burrell Estate map shows the oblong swimming pool pond but no bathhouse is evident and the canal or ditch and three ponds near the house have not been illustrated on the map. The omission of the three long ponds near the house may indicate that these had fallen into disuse, dried up or been filled in possibly as part of works carried out to at least partially complete Humphrey Repton's recommendations for Langley in 1790 as Repton disliked formal gardens.

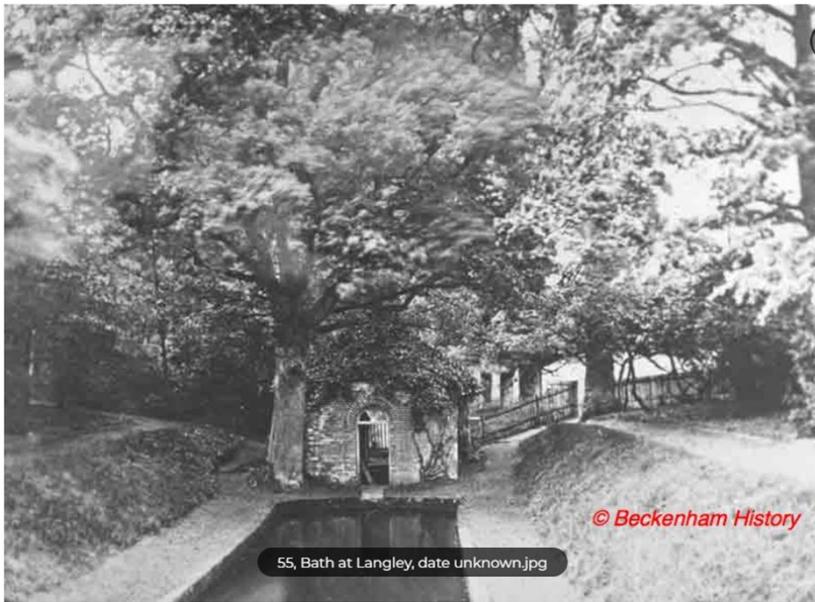
This photo on Beckenhamhistory.org (courtesy of Ian Muir) is the best impression of what the pool and bathhouse looked like. The photo is undated but seems to be before 1910 according to evidence that the Goodharts maintained the feature to some

extent. A large tree growing at the corner of the bathhouse would be undermining the walls. There is some evidence that the brick lined walls of the pool are beginning to sag. The door to the bathhouse appears to be missing and the roof is overgrown with ivy. But the surrounds of the pool are well manicured. The remains of a shingle path around the pool can be found in places but mostly covered over with soil slumped from the banks.

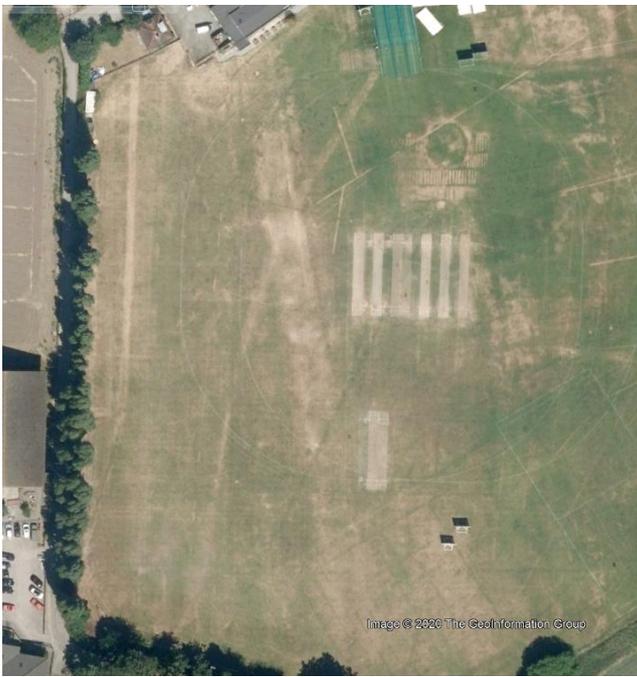
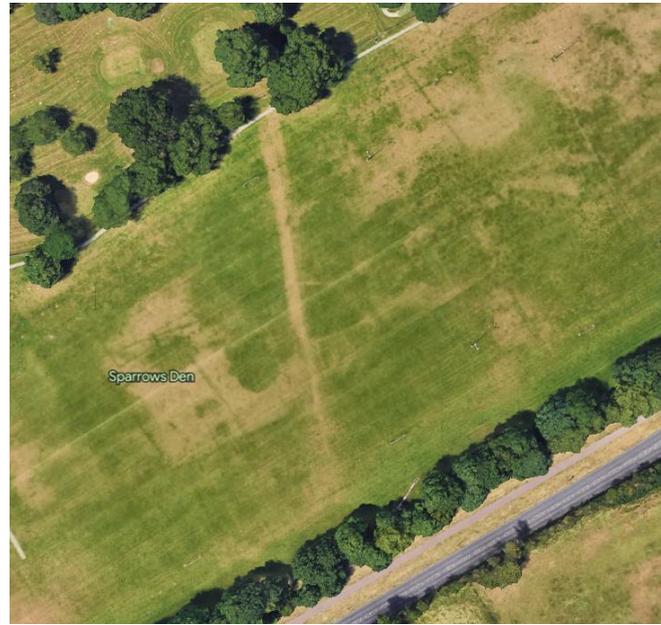
With aerial photography available on such sources as Google Earth we can see evidence of the road from pictures taken in dry periods when the road causes scorch marks in the grassed areas that cover the road. The best places to see these marks are at Sparrows Den West Wickham and across the Old Dunstonians Sports Ground near Langley Park School. If we join these visible features on a map it takes a line across Langley Park Golf Course where it seems to be visible along one of the fairways.

The Roman road crossing Old Dunstonians sports ground and at Sparrows Den.

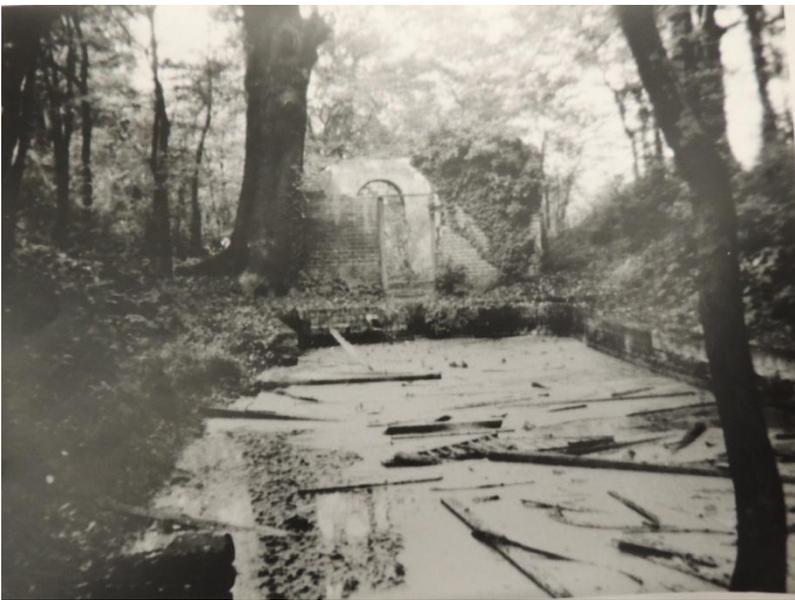
This picture above from the G.W. Tooke archive possibly from circa 1950 shows the bathhouse in a more advanced state of decay. The timbers floating in the pool we may assume are the timbers installed to support the sides of the pool and one side has collapsed. It is said that a lot of vandalism advanced the decay but pure neglect after the demise of the Langley estate and the fire which destroyed the mansion in 1913 did not help. The large tree by the bathhouse is still standing and larger than the earlier photo. The roof of the bathhouse has collapsed and the banks around the pool are advancing into the pool covering the path.

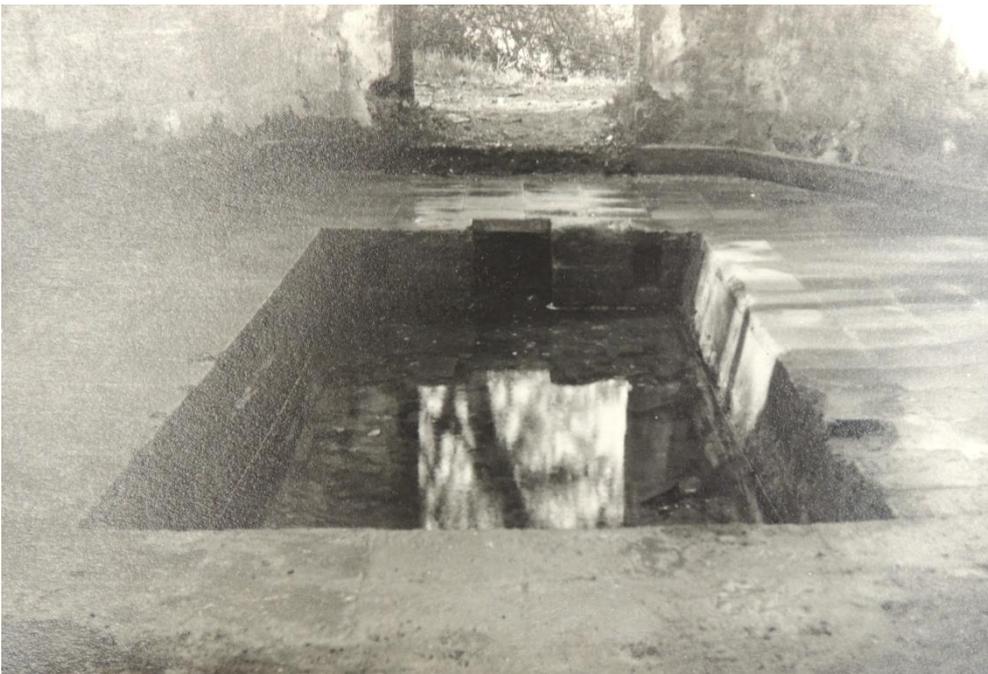
This picture shows the interior of the bathhouse possibly 1910 or after Tooke and a colleague carried out some cleaning in the 1950's. We can see a contiguous surround to the plunge pool with what looks like the outlet sluice. The interior of the bathhouse is roughly octagonal with recesses at the sides which may have accommodated benches at one time. It's possible to imagine an enclosed space with perhaps some rudimentary form of heating for a dip in colder periods while the outdoor pool may have been used for swimming? The sunlight on the floor seems to indicate that the roof is missing. There is no evidence of windows apart from the doors at either end.

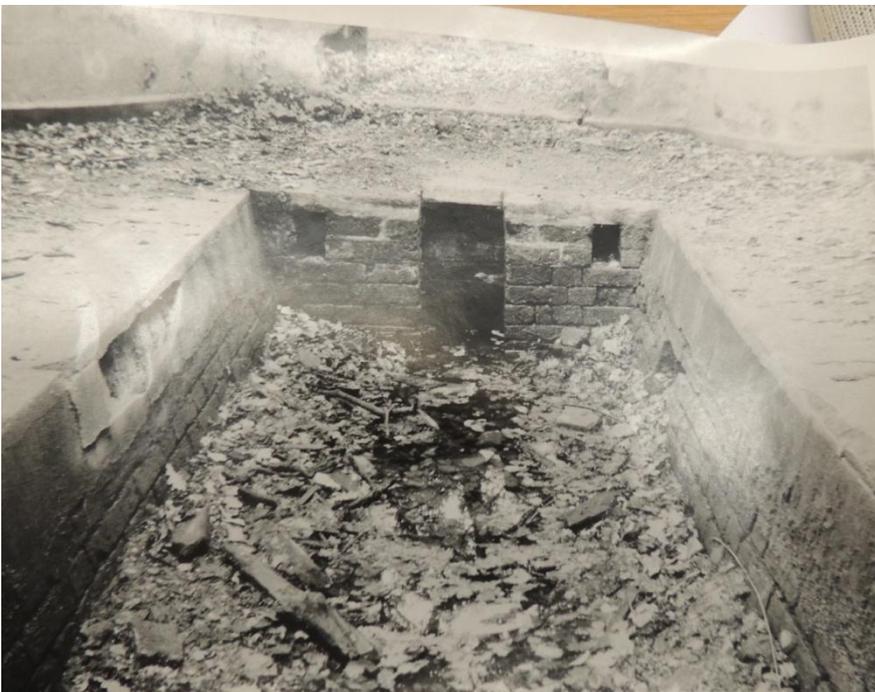
It's unclear whether this picture is before or after the previous one but further investigation of Tookey's archive will probably clarify. Nevertheless it looks in a poorer condition in this one than the previous one. Tookey comments on clearing rubble from the floor of the pool and carrying out some repairs. How he drained it is unknown but there was a period when the spring dried up for a while.

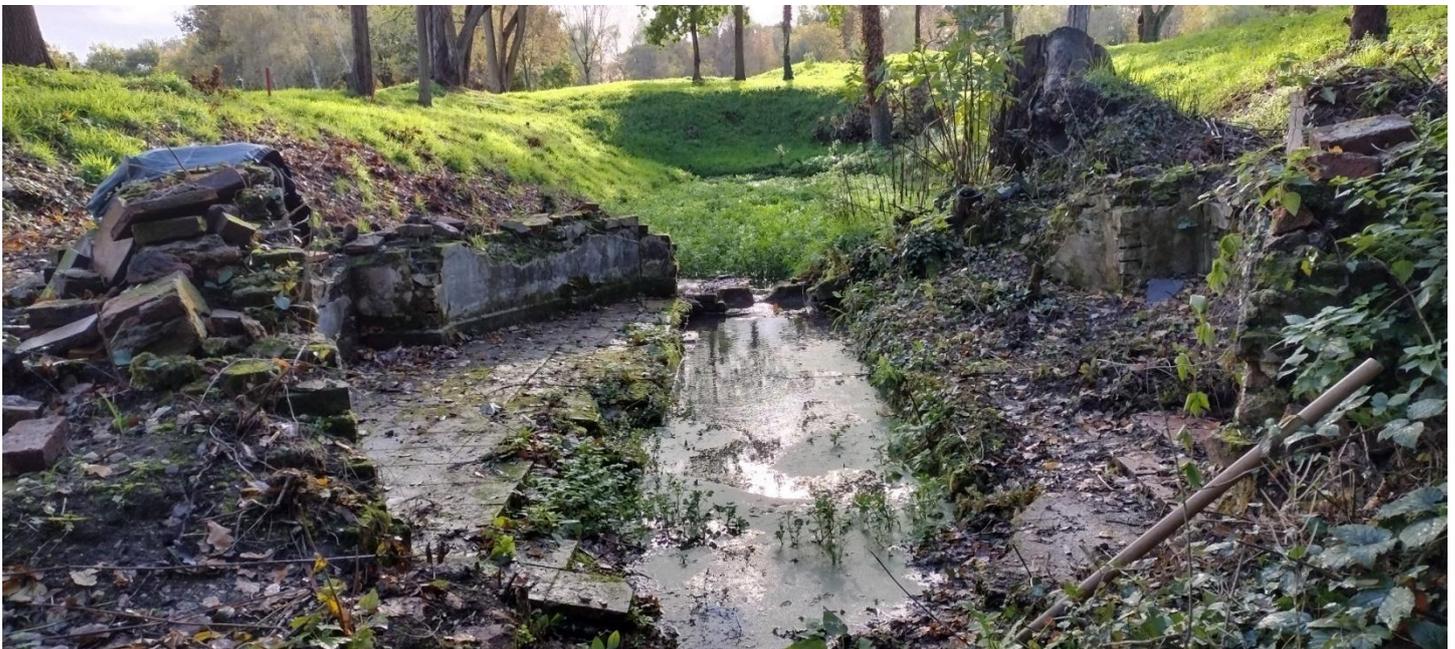
Fast forward to today's visible evidence and the long pond or bath is still there although somewhat overgrown with watercress etc. (This watercress has died off in winter 2022/23 and we'll see if it returns). The remains of the 'Roman Bath' are evident although in a severe state of decay. The ditch or canal is still a wide running stream until it gets to the vicinity of the first long pond near the site of the house. The water is then diverted away across what was Oak Field, now part of the golf course. A depression in the ground is present where the first long pond would have been and then another depression is where the longest pond would have been. This is adjacent to a present day golf green which seems to be on top of the site of the filled in smallest pond. Various ditches are across the golf course and there is still a lake in front of the club house which was there throughout the period for which we have maps although it is smaller now due to some partial filling in. The ponds on the map just above the G and L in Langley have been filled in and are part of the grounds of the School or sports fields. Langley house itself went through at least three rebuilds which are evident from the maps and prints or photographs of the houses.

Looking South, the "Roman" bathhouse and cold bath/plunge pool with pool beyond. Overgrown with watercress etc. October 2022.

Initial aims would be to arrest further decay by removing plant growth which eats into masonry. Stabilise the water level which is flowing around and under the walls of the bath. Remove some soil which is putting pressure on remaining parts of walls. It is likely that the large tree now a stump has undermined the structure and rotting away of the roots could be contributing to further subsidence. Perhaps the only long term solution would be to record what is left and accept that nature will eventually reclaim the site.

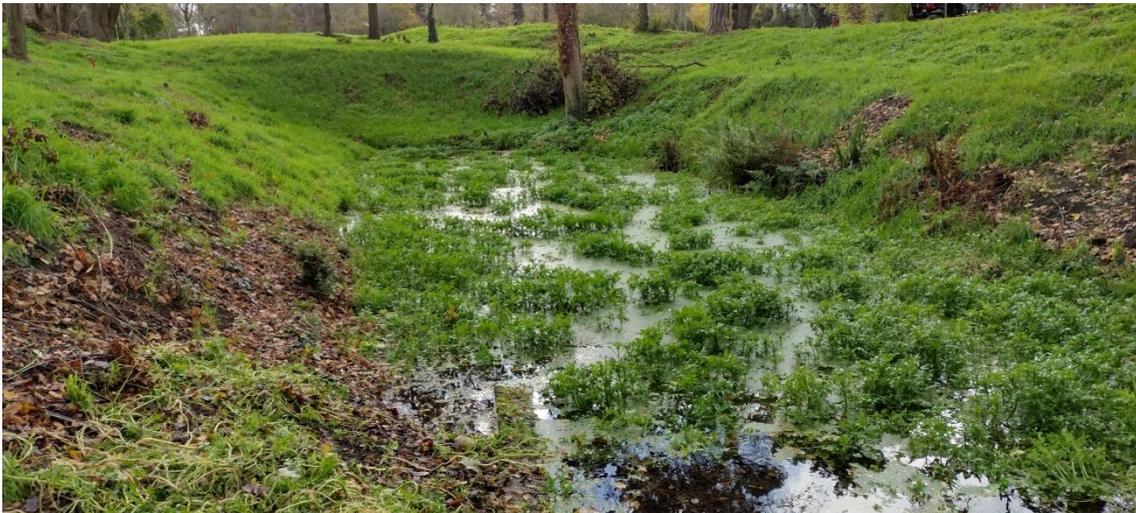
This picture taken from the end of the long pond October 2022, you can make out the banking encroaching on the edge of the pool which is covered in watercress which was perhaps a purpose of some of the pools as watercress was a 'fast food' for labourers. The brick surround has probably collapsed into the pond.

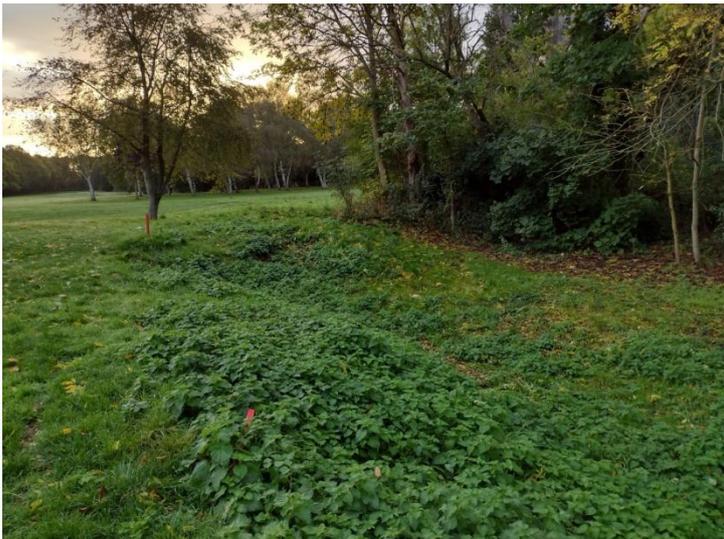
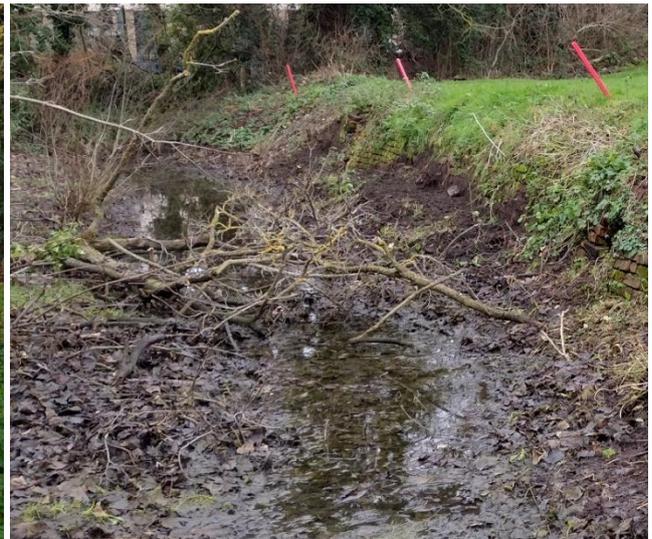
Depressions of a Long Pond near the site of the house

The eastern end of the longest pond is approximately at the tree top left of this picture and some walling on the right side in the second picture.

At the point from approximately where this photo was taken there are the remains of some brick lining to the edge of the pond. The extent of the wall needs investigating. It is laid at an inclined angle and we assume the other ponds would have been of the same construction? We have exposed a bit more of the wall which as some collapsed sections which might be repaired. One part of the wall has been removed in the past to install a land drain. There doesn't seem to be any mortar between the bricks so they may have been laid with clay mortar. Its hard to imagine that all of any lime mortar would have eroded away.

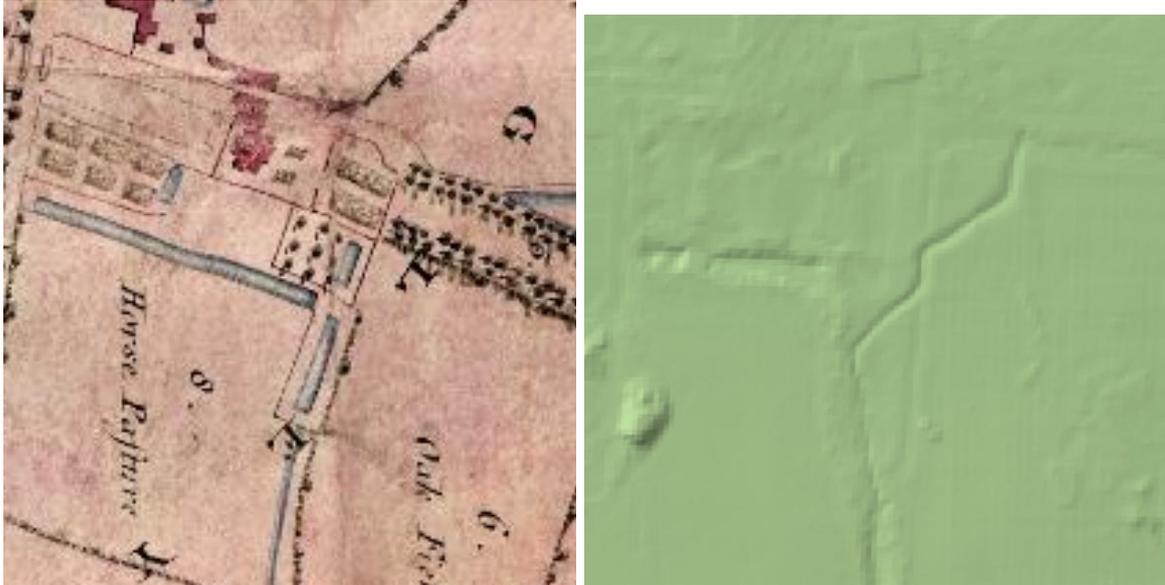
The two smaller ponds running north/south are now filled in but we can see some outline in LIDAR ground radar images

The LIDAR image on the right shows the remaining part of the long pond, the end of the canal at bottom with drainage ditch across the golf course. Where the end of the canal turns into drainage ditch the vague outline of the southernmost of the three ponds can be followed. Some outline of the northernmost pond can be seen running up to the square golf tee. We could search for any wall remains where the drainage ditch zigzags on the line of this feature.

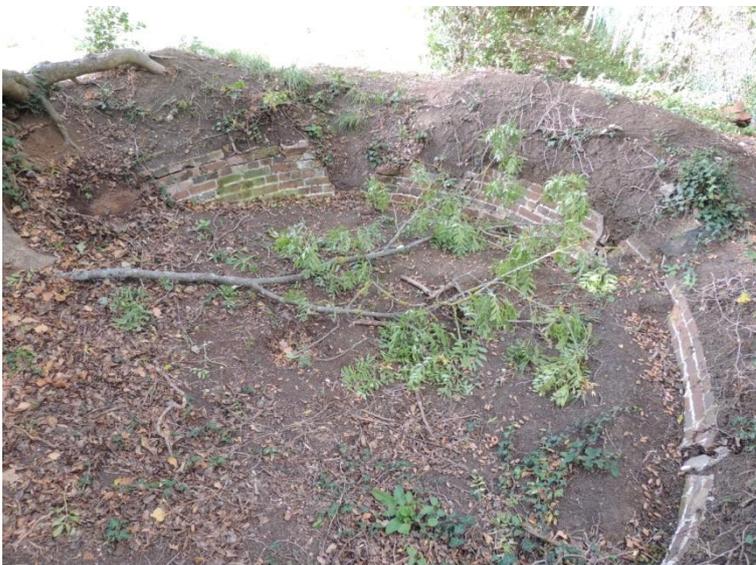
What remains today is the brick lined pit of the well approximately 12 feet in diameter. The structure above ground level is gone, either fallen into the pit or removed and the pit is full with at least the top few feet of earth. We were curious as to the

profile of the pit either tapering or bowl shaped but revealing a few courses of bricks indications a tapering structure probably similar to nearby Kelsey Park Ice Well which is almost intact. Probably both structures are of similar date and maybe constructed when both sites were in the possession of the Burrells?

Although there is some desire to excavate the well, it is probably advisable to leave it full of earth for structural soundness and safety. Curiously the upper structure is drawn as a rectangle on maps rather than an igloo shaped dome.

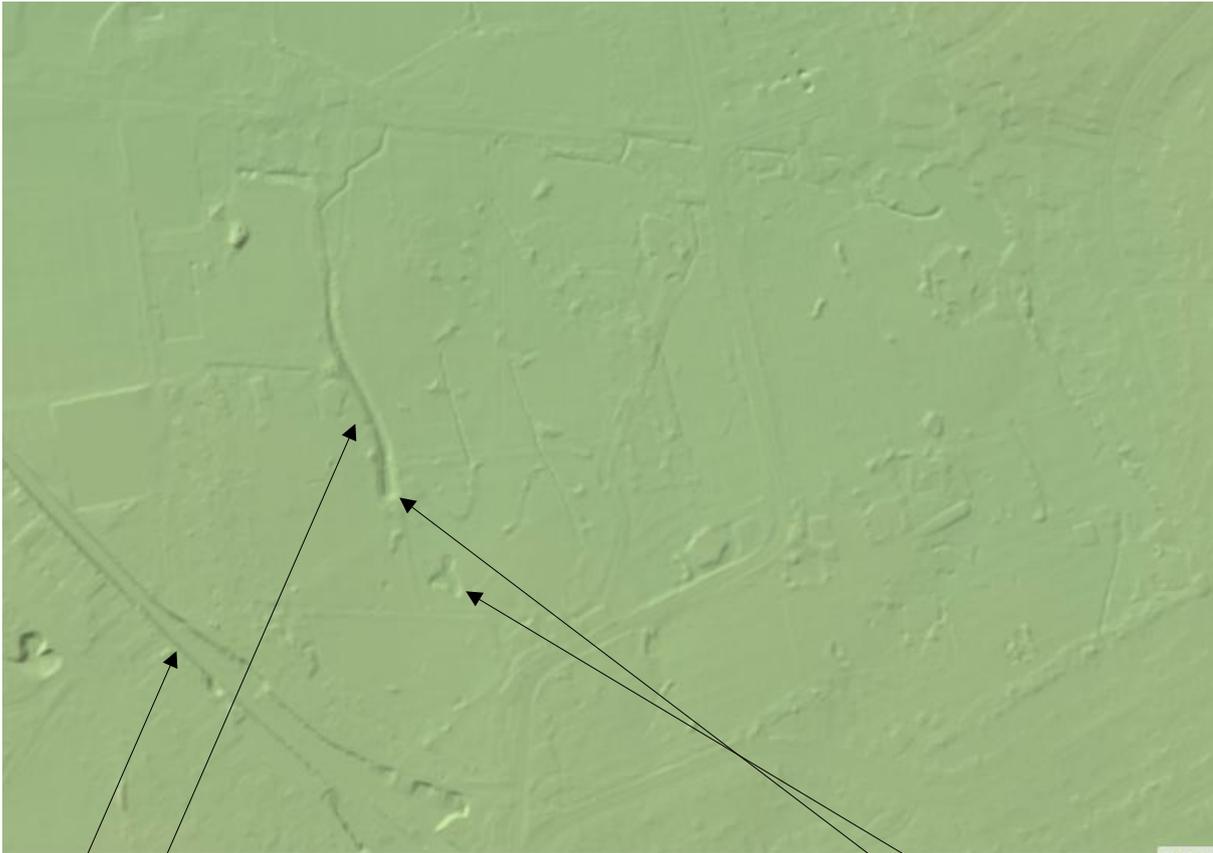
The LIDAR image shows us ground features with vegetation stripped away so any surviving features are revealed along with landscaping associated with the golf course.

Bottom left/diagonal route of the railway and West Wickham station. Left of centre Roman bathhouse/swimming pool with canal running north. Just below the swimming pool, slightly to the right is the pit or quarry.
